Condition Assessment Perrydale Station Perrydale, Oregon

By: Historic Preservation Northwest
For: The Northwest Rail Museum and the Pacific Northwest Chapter of the National
Railway Historical Society
Date: July 30, 2007

By: Historic Preservation Northwest
1116 11th Ave SW
Albany OR 97321
541-791-9199

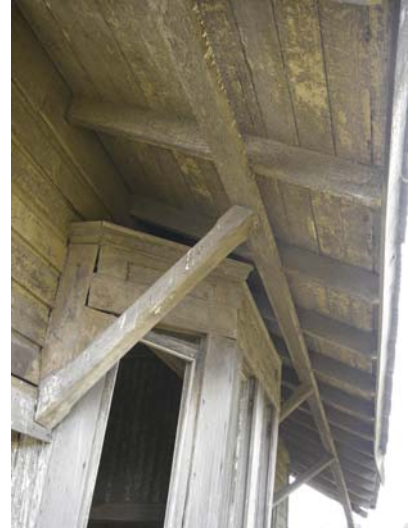
The current metal roof has been well worn and is likely the sole architectural element that allowed the building to survive until today. Since windows and doors are missing, it is difficult to tell if the roof leaks, but if it does, it does not leak much. The metal roofing comes in two-foot-wide panels consisting of six corrugations and a W at the overlap. Each metal panel runs from the ridge to the eave. All metal panels are still attached and secured. The ideal replacement for the metal roof would be a return to a wood shingle roof as shown in the historic photographs and based on physical evidence revealed during tear off. *Preservation Brief 19: The Repair and Replacement of Historic Wooden Shingle Roofs* gives a more detailed description of the steps in installing an appropriate wood shingle roof. The roof is small (i.e., 1,000 square feet) so a wood shingle versus three-tab composition roof should not be cost prohibitive.

Looking under the south eave at the roof structure.

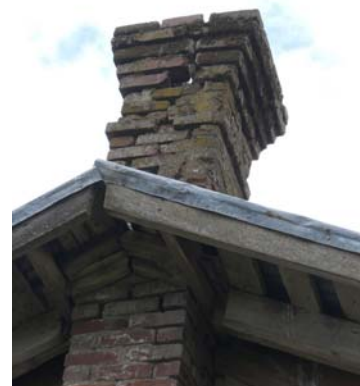
Skip sheathing at chimney.

The 1" x 6" skip sheathing appears in good shape except for two locations. Around the chimney and at the southeast corner the skip sheathing is failing due to lack of support. Further repairs to the sheathing will be limited and self-evident upon removal of the metal roof and existing wood shingles. If the chimney is moved or removed, the sheathing will need repair at the current chimney location. During tear-off, all sheathing should be inspected. This would be an opportune time to evaluate the original shingle pattern, if not for in-kind replacement, then for future reference.

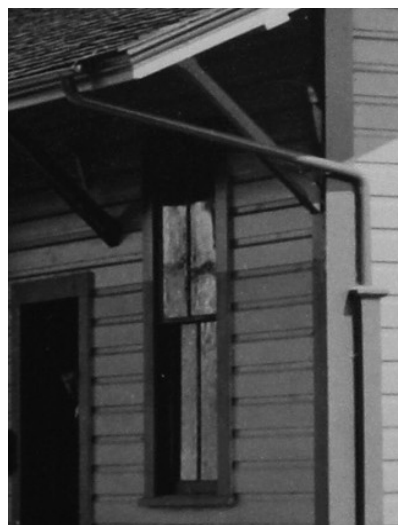
Currently, there are no gutters on the station. In the circa 1930 photograph, a gutter can be seen on only the south side of the building. This was installed to protect people entering the building from the drip edge. No gutter appears on the north side of the building in any of the images, though a remnant of a metal down is attached to the northeast corner of the building. With the four-foot-wide overhang, gutters are not necessary for the structure. The deep eave is far enough from the building to prevent water from splashing up on the siding. A gutter over the entrance is appropriate to protect visitors; however, it should not be a standard, bent aluminum, 5" deep gutter. If a gutter is desired, a smaller half-round or K-type gutter would be more in keeping and less obtrusive on the building. The circa 1930 photo also shows a downspout on both ends of the gutter run.

Gutter detail from circa 1930 photograph.

The down was boxed in where it attached to the building – a detail that should be recreated if a gutter is installed.

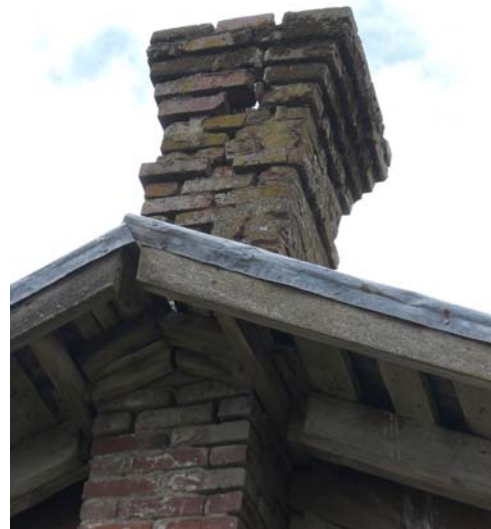
The entire chimney leans at a precipitous angle to the south following the sinking south side of the building. When the building is moved or salvaged, this chimney will have to be dismantled. The bricks that come loose easily could be reincorporated into a new chimney at its new location. If the building were to take on a pre-1930 period of significance, then the chimney should be rebuilt in its former location between the passenger waiting area and the agent's area. In the former location, the chimney was a hanging chimney, approximately eight feet long, and supported by the stout partition. The stove pipe entered into the side of the chimney at nine feet above the floor.

The chimney top has lost much of its mortar and is holding together only through habit.

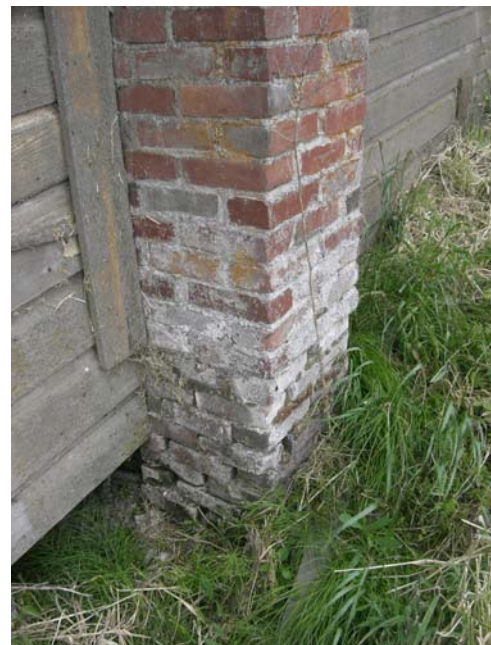
The base of the chimney has lost much of its mortar. It is unknown what is below grade.

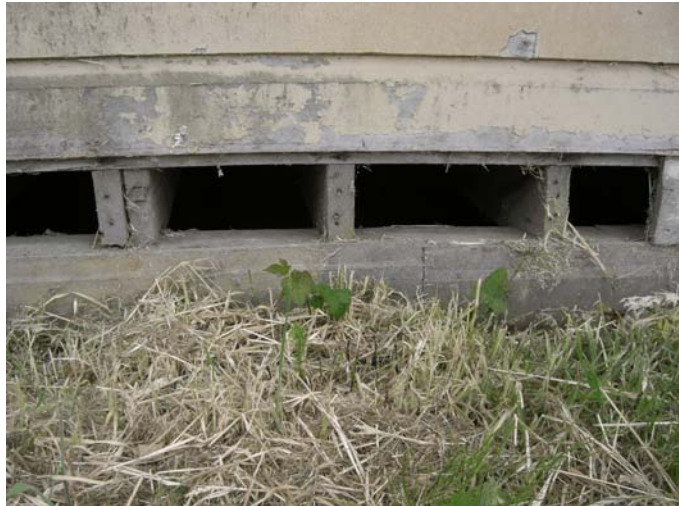
There is a ring of concrete blocks supporting the two beams at the north and south sides. The center beam is lightly supported. All the concrete blocks have sunk well into the earth. These were probably installed within the last 40 years to help support the building. At that time, the water table was probably removed. No rot was visible on the floor structure, however, most of the floor structure was invisible due to lack of access and its sinking into the earth. To say the least, the floor structure has greatly decayed in the southeast corner.

The 2x6 floor joists sitting on 4x6 beam which in turn are supported by a ring of concrete blocks.

When visited in February, the southeast corner of the building was standing in water. If the station were to be moved, the beams would most likely have to be replaced along with the floor structure in the southeast corner. In other words, some of floor structure work would have to be performed on the building before it can be lifted and moved. However, this structural work would have to be done anyway if the building were to be disassembled and re-erected in a new location.

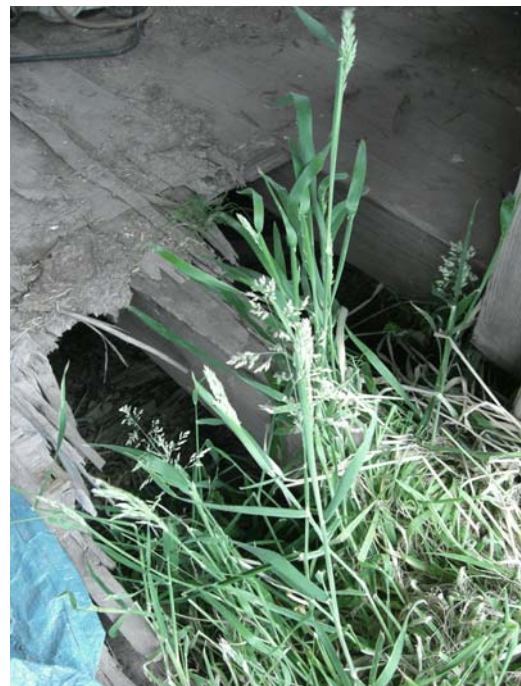
Exposed floor structure at the south entrance.

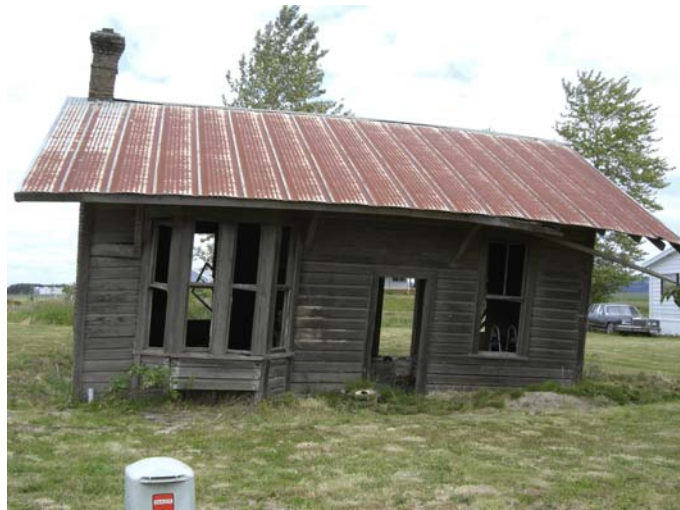
The south elevation of the Perrydale Station.

The building's list is especially noticeable on the south wall, with a pronounced lean forward and drop to the east. Missing elements include exterior siding boards at the base of the center section of the bay, trim at the front corners of the bay, the water table along the base of the building, and a bracket that was attached to the eastern corner board. Three brackets remain. The west-most bracket is unstable because the siding board to which it is attached is coming loose. The fascia board is broken off, just to the east of the window. The south elevation is a weather side and is almost completely stripped of its paint. A very small paint trace remains to the east of the bay at the spot where a box (possibly a mail box) was mounted after 1930 but before 1960. This box no longer exists. A "Perrydale" sign dating to the postal period after the 1930s was once attached to the wall above the door. There are reports that this was donated to the Polk County Historical Museum, but unfortunately it is missing. Some porcelain insulators for electrical wiring can also be seen attached to the frieze board.

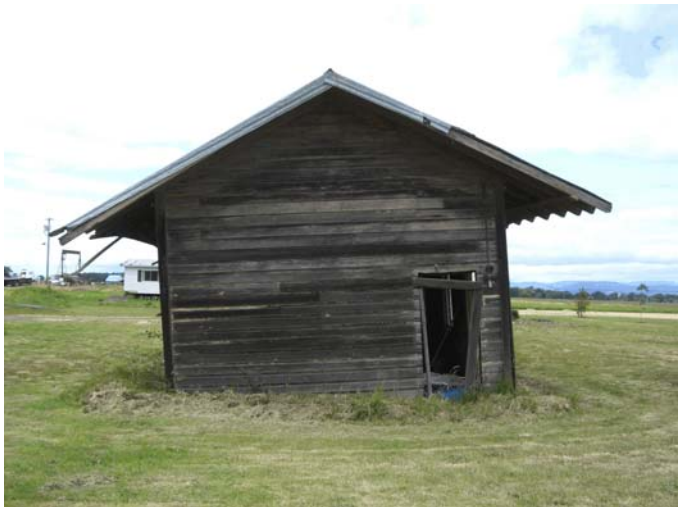
The east elevation of the Perrydale Station.

The east elevation, one of the gable ends, includes a door opening near the north corner. This wall has sunk into the ground more than the other walls and has slid slightly off its rim joist. A defunct electrical meter (with corresponding box on the interior) is attached to the wall at the top and to the north of the opening. The meter was installed after 1930 but before the 1960s. Some yellow paint fragments can be observed toward the south end of the elevation, chiefly near the grooves where the siding boards meet. Missing from this elevation is a boxed in downspout that was attached to the wall next to the south

corner board. The water table board along the base of the building is missing and the corner board on the south end is splitting. Like the south elevation, the east elevation also once sported a "Perrydale" sign, which was still present in photos from the early 1960s. This sign dated to the railroad period, unlike the sign on the south elevation, which dated to the postal period.

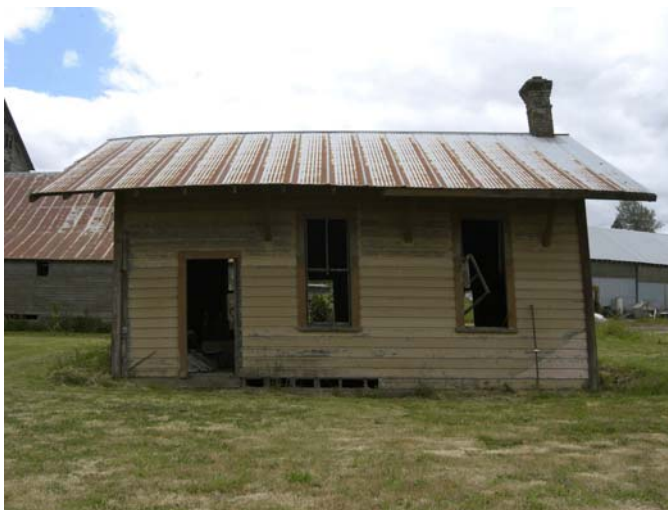
The north elevation of the Perrydale Station.

No historic photographs of the north elevation were discovered making it difficult to determine what is possibly missing from this elevation. The wall leans away from the observer, thereby exposing more of the base of the wall than any other elevation. The level below the door opening is roughly 14" tall or the exposure of two siding boards. The lean toward the east is less pronounced here. The north wall includes a door in the east 1/3 of the wall and two windows in the remaining 2/3. Before the removal of the freight room on the west end, the windows would have taken a much more central position. Because of the lack of photographs, it is not possible to determine what added openings the freight portion may have had. Stations usually have few windows lighting their freight room, so more than likely there were no windows or doors into the freight room on this elevation. Like the south side, the north side is also missing an eave bracket once attached to the east corner board. The eastern fascia board is also missing. A section of the siding is missing below and to the west of the door opening. This allows for inspection of the floor joist system. The south side is chiefly notable for its relatively high degree of paint retention. The wall is clearly yellow, with dark mustard window trim and dark brown window sashes.

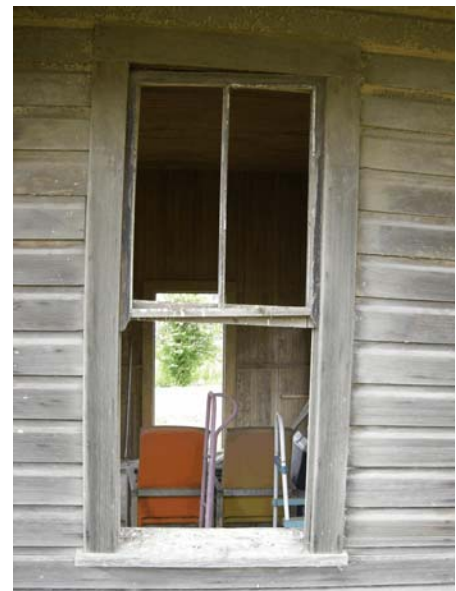
The south side's standard window is placed toward the east end of the building. The window measures 2'8" by 6'6". The station's standard windows were 2 over 2, with 14" by 36" panes of glass in the upper and lower sashes. The upper sash here is essentially intact, however, the lower sash is missing its muntin.

The standard 2/2 window on the south side missing a muntin.

Once stripped, an appropriate wood filler (such as Abatron Epoxy Filler) could be used to repair some of the minor cosmetic damage to the window frames. Some of the major damage, notably the missing muntins and the entire northwest window will require reconstruction. However, where possible, repair rather than replace is the credo to follow.

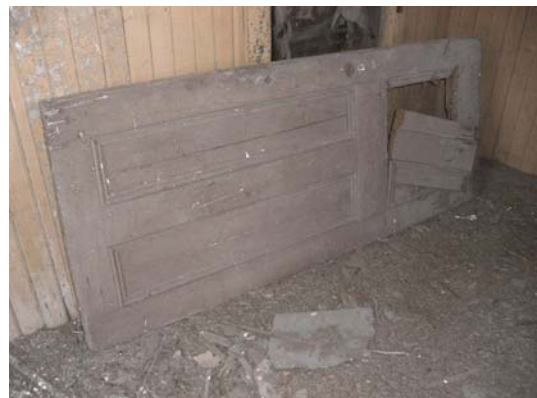
Remnant door lying inside the station.

All doors and hardware were supposedly removed by someone who was going to take the station from the county several years ago. It is critical that the doors and hardware are returned the station. If the door and hardware has disappeared, the doors and hardware will need to be replaced. The doors are not unusual and could probably be obtained from an architectural salvager. If matching doors cannot be found, then they will need to be reconstructed based on the sample remaining door and historic photographs. Hardware would be much more difficult to

obtain and hopefully can be returned by the museum; otherwise, the replacement hardware would be speculative and based on c.1879 availability. Nonetheless, until replacement can be accomplished, the openings need to be filled with some sort of temporary doors or plywood panels to protect the building from the elements and intruders.
