- By: Historic Preservation Northwest 1116 11th Ave SW Albany OR 97321 541-791-9199
- For: Chris Bentley Benton County Community Development Department 360 SW Avery Ave Corvallis OR 97333 541-766-6819

INTRODUCTION

This report is a condition assessment for the Monroe Railroad Station located on Front Street in Monroe, Oregon. The report is based on a site visit made by Historic Preservation Northwest (HPNW) represented by David Pinyerd, Bernadette Niederer and Chris Bell on May 17, 2006. The site visit was on the behest of Chris Bentley of Benton County's Community Development Program. Our assigned task was to create a condition assessment report for the station building. No invasive measures were taken to analyze the building. All photos were taken by HPNW unless otherwise noted. "Preservation Briefs" are mentioned several times in this report. They are available online from the National Park Service at www.cr.nps.gov/hps/TPS/briefs/presbhom.htm

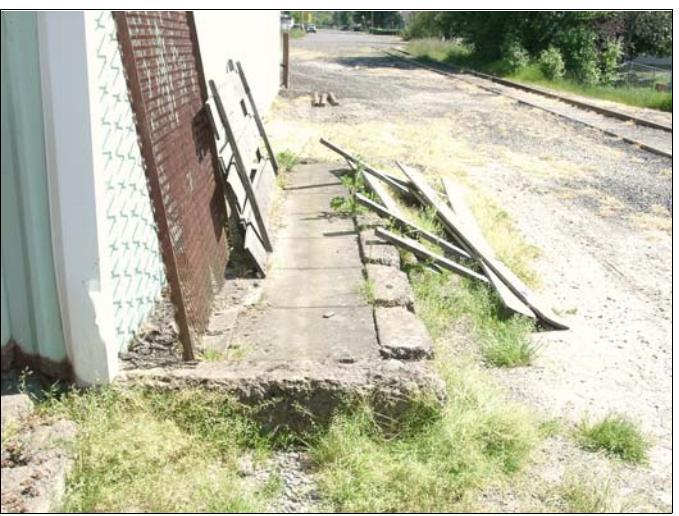
Foundation remnant from the observation bay on the west wall of the passenger portion of the station.

All of the site features pertaining to the use of the station building as a railroad facility should be carefully noted and recorded, especially if the building is moved from its current context.

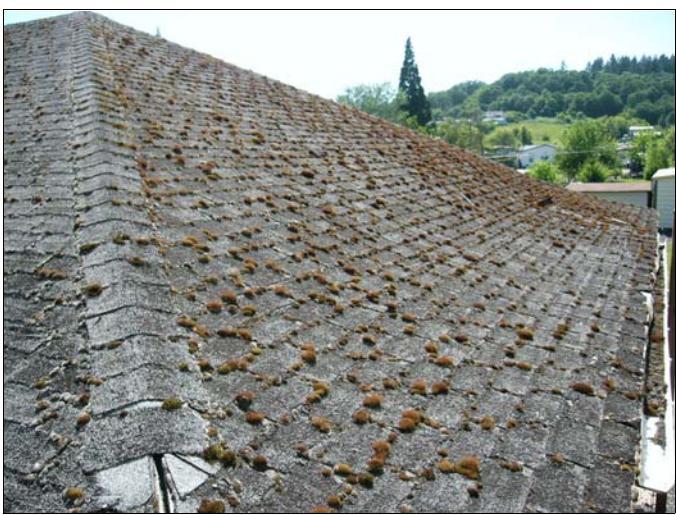
The deteriorated composition roof on the station at the north end.

The current asphalt shingles are extremely deteriorated and in poor condition over the entire roof structure. In many places the asphaltic granules have been completely worn away exposing the tar paper backing. However, the roof does not currently leak according to those who work on-site. The temporary sheet-plastic ceiling inside the station catches dead bugs, not water. Moss grows consistently across the roof particularly on the east

side. The ridge cap along the northeast ridge is missing, and the exposure is permitting weathering to the plywood sheeting. The ideal replacement for the asphalt shingles would be a return to a wood shingle roof as shown in the historic photographs and based on physical evidence revealed during tear off. *Preservation Brief 19: The Repair and Replacement of Historic Wooden Shingle Roofs* gives a more detailed description of the steps in installing a wood shingle roof. Should a wood shingle roof be cost prohibitive, the next best choice would be another simple, three-tab composition roof in black. High-end "architectural" shingles would not be appropriate for the station.

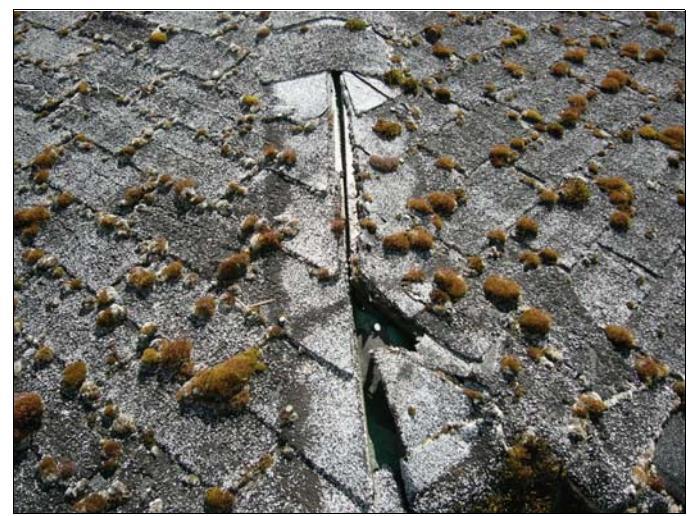
The missing cap on the northeastern ridge.

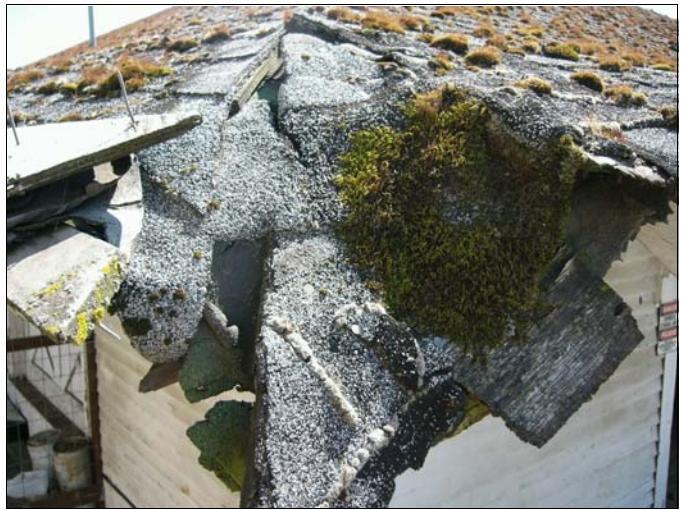
Also, the sheathing at the northeast corner of the roof has been damaged by successive hits by trucks over the years. The complete structure, including the hip rafter, the hip jacks, the pole plate, the purlins, the fascia board, and the shaped rafter tails are

The roof where several trucks have hit the northeastern corner of the building.

damaged and will need repair and replacement. Further repairs to the sheathing will be limited and self-evident upon removal of the asphalt shingles and plywood sheathing. During tear-off, all sheathing should be inspected. This would be an opportune time to evaluate the original shingle pattern, if not for in-kind replacement, then for future reference.

The 5' rafter tails, purlins, and supporting 2' brackets are *the* character-defining features of the station and need to be retained. They should be repaired, and in at the northeast corner, restored. Any additional construction on the south end of the building will need to recreate these elements to the fullest degree.

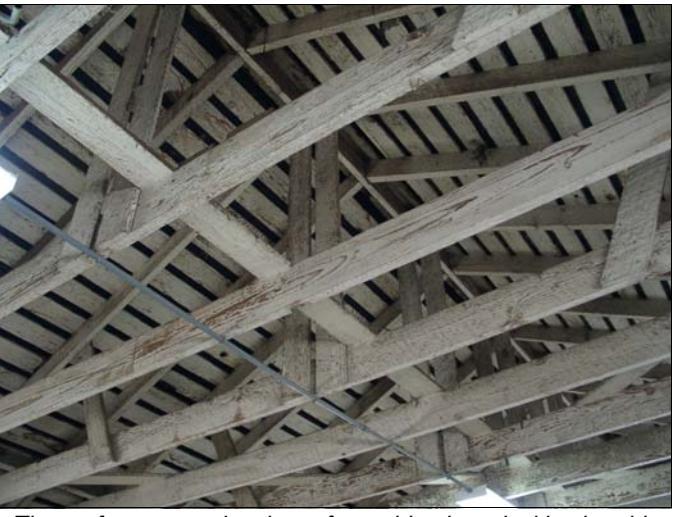
The roof structure is in good condition. Examination of the roof structure in the interior reveals an intact and functioning rafter system with a tacked on "king post." There appears to be no rot or serious deflection in the tie beam. the braces. or the common rafters. There are a select number of rafter tails which will need wood filler, and others will need to be replaced in-kind by taking the shape and dimensions from an existing rafter and recreating them. The fascia boards appear to be deteriorated and not original to the building. The rafter tails are notched to receive a crown moulding to finish

The roof structure showing rafters, ridge board, skip sheathing and braces.

off the roof edge. This crown moulding, visible in the historic photos, should be recreated and installed. It helps protect the rafter tails by supporting the roof shingling out past the ends of the rafter tails.

Once the asphalt shingles have been removed, the substrate should be examined to confirm what looks from the underside to be an intact roof structure. The rafter tails should each be evaluated for rot, especially the tail end where exposure to weathering is the greatest. In most cases, it appears repainting will be the only measure required. In other cases, the Abatron Liquid Wood for consolidation would serve to strengthen the wood and the Epoxy Filler in places of missing wood. In a few cases, complete replacement will be necessary.

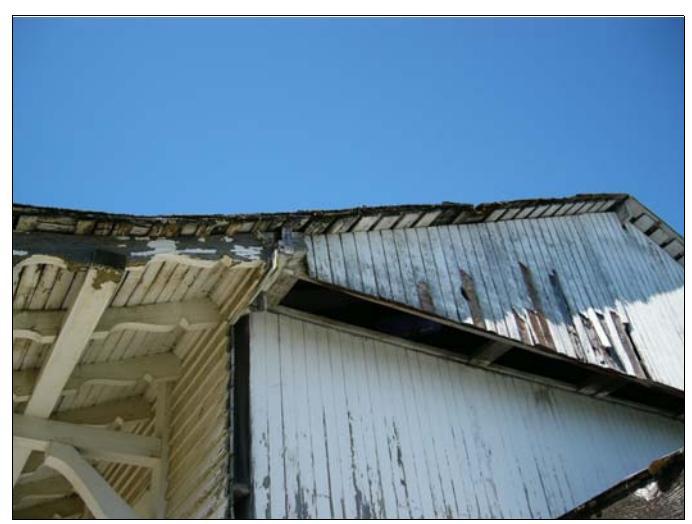
The other area of concern is the sawn-off edge of the roof facing south, which was the result of the lopping off of the passenger station. This has led to a cobbled-together exterior wall with a limited protection from the roof eaves.

South end of the station where the passenger section was lopped off and a shallow eave left behind.

With the earlier removal of the south end of the station, the "exposed" end of the building presents some design challenges and opportunities. A series of decisions will need to be made relative to the siding and the future use of the building. Since it is the most altered, it could be the best place to provide a new entry and

attach whatever additional functions to the building will be needed, as opposed to altering the largely intact freight room. With these decisions, will come the choice about how to address the shortened eave. The shallow eave will always be problematic requiring far more maintenance than the other sides of the building. However, the poor response after the demolition of the southern end of the building does greatly aid in interpretation of the abrupt sawing-in-twain of the Monroe Station.

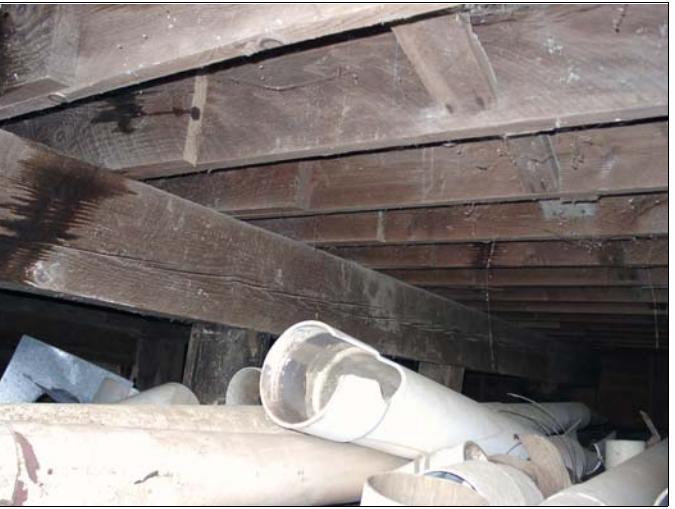
The foundation structure under the station. Years of broken PVC pipe has been tossed underneath.

posts in turn rest on a variety of 3" x 12" blocks directly on the earth. Five of the blocks have sunk entirely into the earth along the center run at the south end. There is some slight white rot visible on the blocks but none on the posts.

The rim joist matches the joists and is $1-3/4" \times 11-1/4"$. Posts run downward from the rim joist to provide structure for the foundation skirt. At the bottom of the foundation skirt is a $1-3/4" \times 7-1/2"$ member laid flat on the ground. There is some white rot visible on this member at ground contact at the center of the west wall.

There is no moisture barrier in the crawl space. Clearance under the beams averages two feet. The earth has a mix of gravel, especially around the edges, and was slightly damp. Workers on site mentioned that ponding occurs on the outside of the west wall and probably extends into the foundation area. The area around the building is relatively flat; however, there is not positive drainage away from the station.

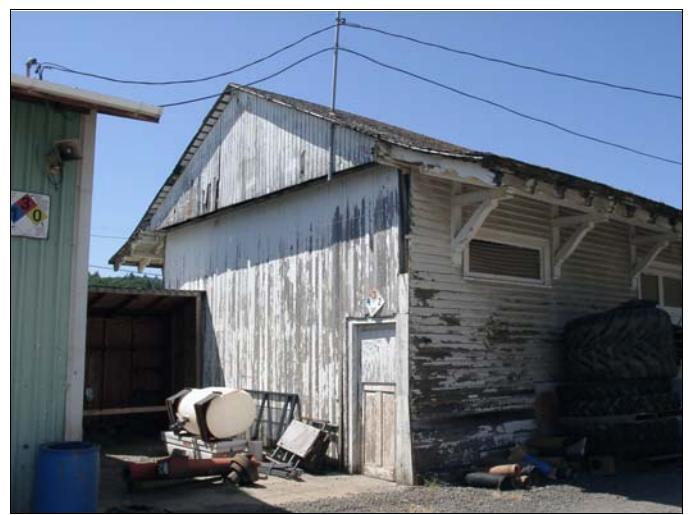
The "exterior" south wall is actually an interior tongue-and-groove wall. The gable is filled with non-historic T-111 exterior plywood. The T-111 gable end actually overhangs the tongue-and-groove wall leaving a one foot wide opening to the attic space. The ends of the siding and sheathing where the north third of the building was cut off have been exposed to the elements since the demolition.

The vertical tongue-and-groove is 3/4" x 3" and is in good condition. It has held up to the elements well but should not be exposed to the weather in the manner that it is. The T-111 is in poor condition and is delaminating in several places. The south door to the exterior is an interior door and should be restored and returned to interior use.

South elevation where the passenger portion was removed.

This end of the building needs to be addressed and several options exist. If no additional space is needed for the building's new use, then the south end of building could be finished off

with a hip roof mirroring the north end of the building. If additional space is desired for the new use of the building, such as restrooms, the south end of the building should be modified to accommodate the new use. This end is the best place to house any additional space requirements. Recreating the passenger portion of the building would be an ideal addition to this end of the building and solve the weather exposure problem the south end currently suffers. Springfield, Oregon, sympathetically adaptively reused their station in the early 1990s and should be consulted for guidance on this station.

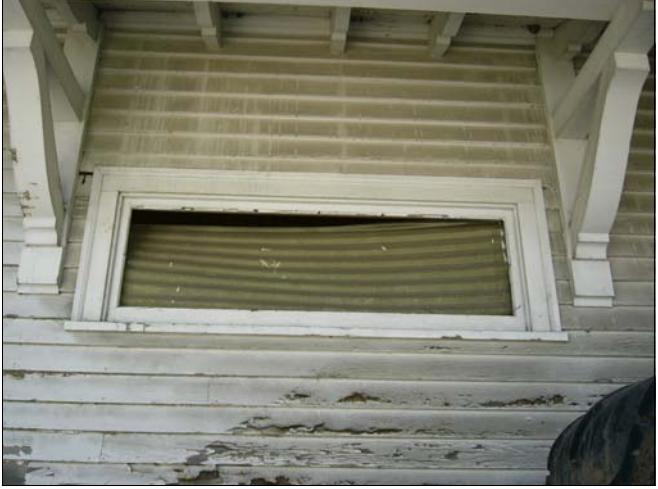
All three window sashes are in good condition. Their limited exposure to weather is largely due to their location well under the wide eaves. The work required by the windows will be minor and should occur after the building is moved. The fourth, boarded-up window was much larger and lit the small room on the south end from the west side. It could not be evaluated and is hopefully still intact under the plywood.

One of the broken out windows filled with corrugated fiberglass.

All window frames and sashes should be given a paint analysis to determine the original paint color. According to the historic photos, it appears the windows frames were originally a darker color (most likely dark brown) to contrast with the Southern Pacific yellow of the body, and the sashes were painted white or a lighter color. Once the paint color is determined, the window should be cautiously stripped for repainting. Some minor damage has occurred to the window frames; therefore once stripped, an appropriate wood filler (such as Abatron Epoxy Filler) could be used to repair cosmetic damage. Repair rather than replace is the credo to follow.

After stripping and wood repair, a glass replacement pane should be installed. Attention should be paid to the type of glass (i.e., frosted or clear) and original thickness by studying the width of the vacated setting. Once the glazing is stripped with a putty knife and heat gun, the wood should be double primed and the glass installed, glazed (e.g., DAP glazing compound with linseed oil), and the window frame painted appropriately. The National Park Service's *Preservation Brief 9: The*

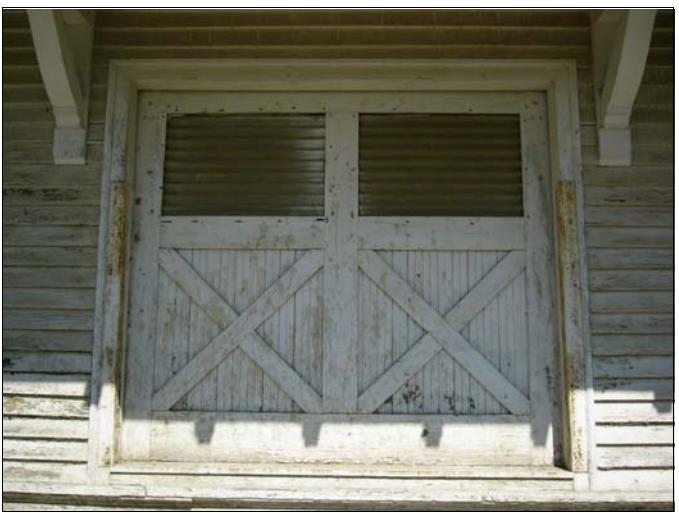
One of the freight doors with its lite filled with corrugated fiberglass.

batten-style with the use of vertical boards held together by diagonal bracing with two lites above. The original lites above have been replaced with the corrugated fiberglass to provide light and durability against vandalism. A single-passage door connected the freight area with the passenger area. It is now an exterior door on the south end of the building. It is a two vertical-panel door with a glass lite above that has been broken out and filled with plywood.

All four sliding doors are in good condition. Their limited exposure to weather is largely due to their location under the expansive eaves. The single passage door, however, has seen a lot of exposure and is in great need of maintenance. A fifth sliding door could be recreated to match the other freight doors and installed at the missing door position (west side, north end). However, the track for the door has also been removed. The tracks are not too unusual and could be found at most barns in the area. Undoubtedly there are used tracks available for sale in the area. The work required by the doors should occur after the building is moved.

All the doors and door frames should be given a paint analysis to determine the original paint color. According to an early photograph, it appears the exterior passage doors were polychromatic, with the panels painted lighter than the rails and stiles. The same could also be discovered for the interior passage doors and the freight doors, inside and out. Once determined, the doors should be suitably stripped for repainting. In the case of the passage door, this should be done once carefully removed. Overall, only minor damage has occurred to the doors and their door frames. Depending on the condition of wood the passage door on the exterior once stripped, the desiccated wood could be consolidated with an epoxy resin. Two products we recommend are Abatron Liquid Wood for consolidation and Abatron Epoxy Filler for replacement of missing wood.

After paint stripping and wood repair, pane replacement should follow. Attention should be paid to the original glass thickness by studying the width of the vacated setting. One side of the molding which held the glass in place will have to be removed, then correctly-sized and typed glass should be installed, followed by appropriate painting of the door frame and doors.

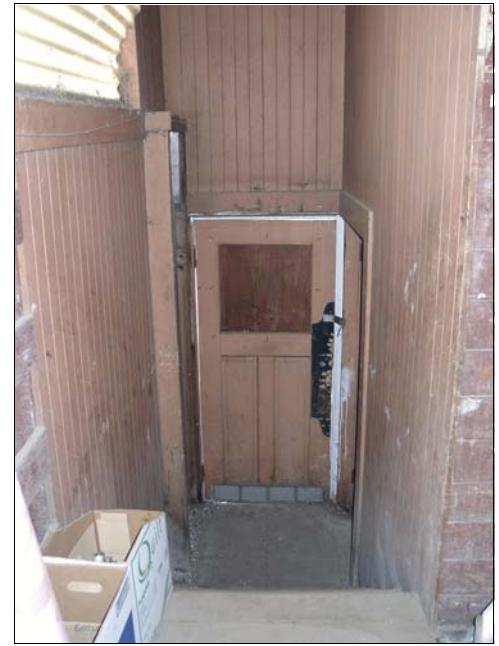
The single passage door down the stairs and out the south end of the station building.

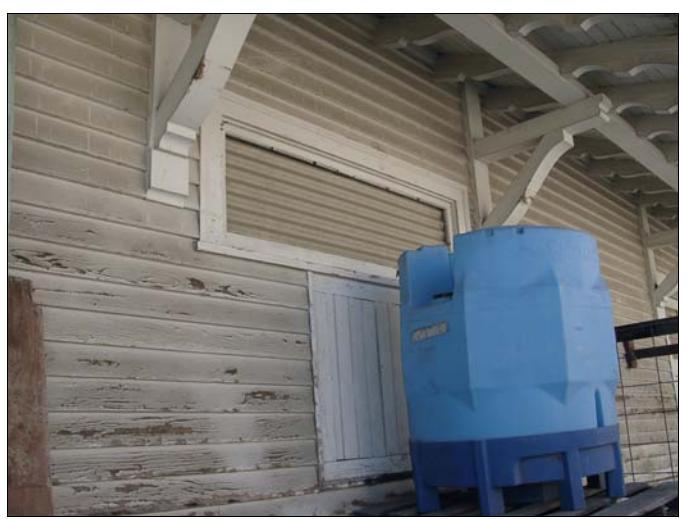
There appears to be two boarded up openings for fire hoses, one on the east side towards the middle, and one on the west side towards the south end. These fire hose compartments appear to have been once accessible on both the inside and outside of the station. Currently, they are boarded up on the exterior. These openings should be investigated. They could be glazed over and kept for interpretation.

Clerestory window with boarded-up fire hose housing below on the east elevation.
