Agency: FCC
Form: Form 621
Project: Genesee
Project #: SC38
Adapt #: WA12-17715-SHP
Surveyor: Dave Pinyerd with Historic Preservation
Northwest for Adapt Engineering, Inc.

Address: 3803 S Edmunds St
Seattle, WA 98118
County: King
NAD 83: 47.5585, -122.285

The project is to bring into compliance an AT&T cellular installation on a building in Seattle, Washington, as shown in Figures 1 through 3. The building is the Toby Building (1903) at 3803 South Edmunds Street. The current AT&T cellular installation consists of seven panel antennas on two racks on the roof of the three-story building. The racks are set well back from the parapet edge and are located near the center of the roof. Three more antennas are proposed to join the existing antennas on the same racks bringing the total to ten panel antennas. Equipment for the antennas is located in the basement and connected internally.

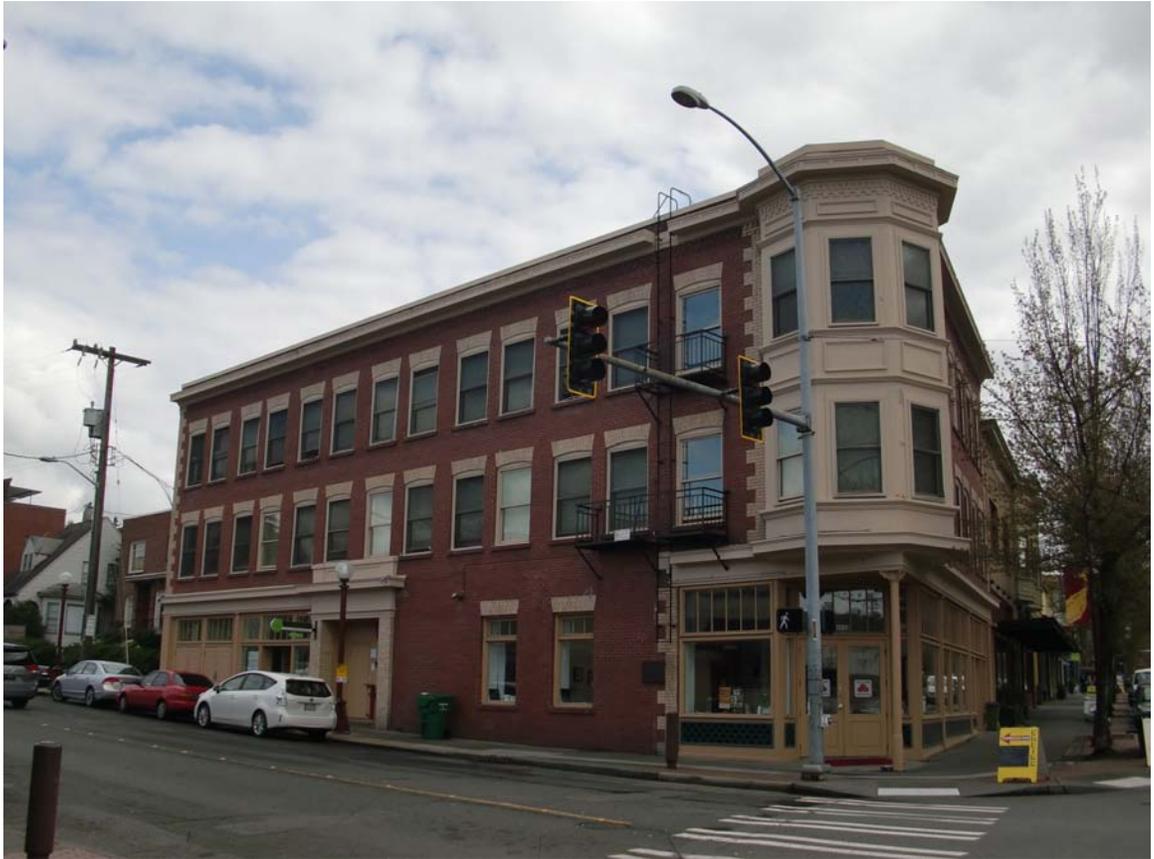
1

Effect: The Toby Building is located at 4850 Rainier Avenue South (alternately addressed at 3803 S Edmunds Street) and was built in 1903, according to DAHP. The building is a historic contributing resource to the Columbia City Historic District and stands at the heart of the district. From the 2004 nomination:

"This three story commercial American Renaissance style building is located on a corner lot. The building is of frame construction and is supported by a concrete foundation. The building has a rectangular plan and a flat roof with decorative cornice. A two story polygonal projecting bay is located on the northwest corner of the front elevation is hold over from the Victorian era. Below the projecting bay, which is supported by a column, the corner of the building is truncated to accommodate an angled corner entry. The majority of the building is clad in brick; the projecting bay is clad in terra cotta. The fenestration consists of evenly spaced modern one-over-one single hung windows. The original window openings are intact and are topped with terra cotta segmental relieving arches with brick sills below. The building has two storefront bays on the front elevation, the main entrance is located on the corner and a smaller storefront entrance is located on the opposite end of the elevation. A single storefront and an entrance to the upper floors are located on the north side elevation. The storefronts consist of expansive glass windows with wood surrounds and transom windows above. Decorative glazed tile are located below the storefront windows. The building remains largely intact despite minimal alterations to the storefronts and the projecting polygonal bay.

The current AT&T cellular installation consists of seven panel antennas on two racks on the roof of the three-story building. The racks are set well back from the parapet edge and are located near the center of the roof. Three more antennas are proposed to join the existing antennas on the same racks bringing the total to ten panel antennas. Equipment for the antennas is located in the basement and connected internally.

The antennas have very little impact on the character-defining features of this building in that they rise above the roofline, however, the two antenna racks are set well back from the parapet edge. One has to stand at least 200 feet from the building to see the tops of the antennas. Consequently, the antennas have no adverse effect on the National Register-eligibility of this listed resource.

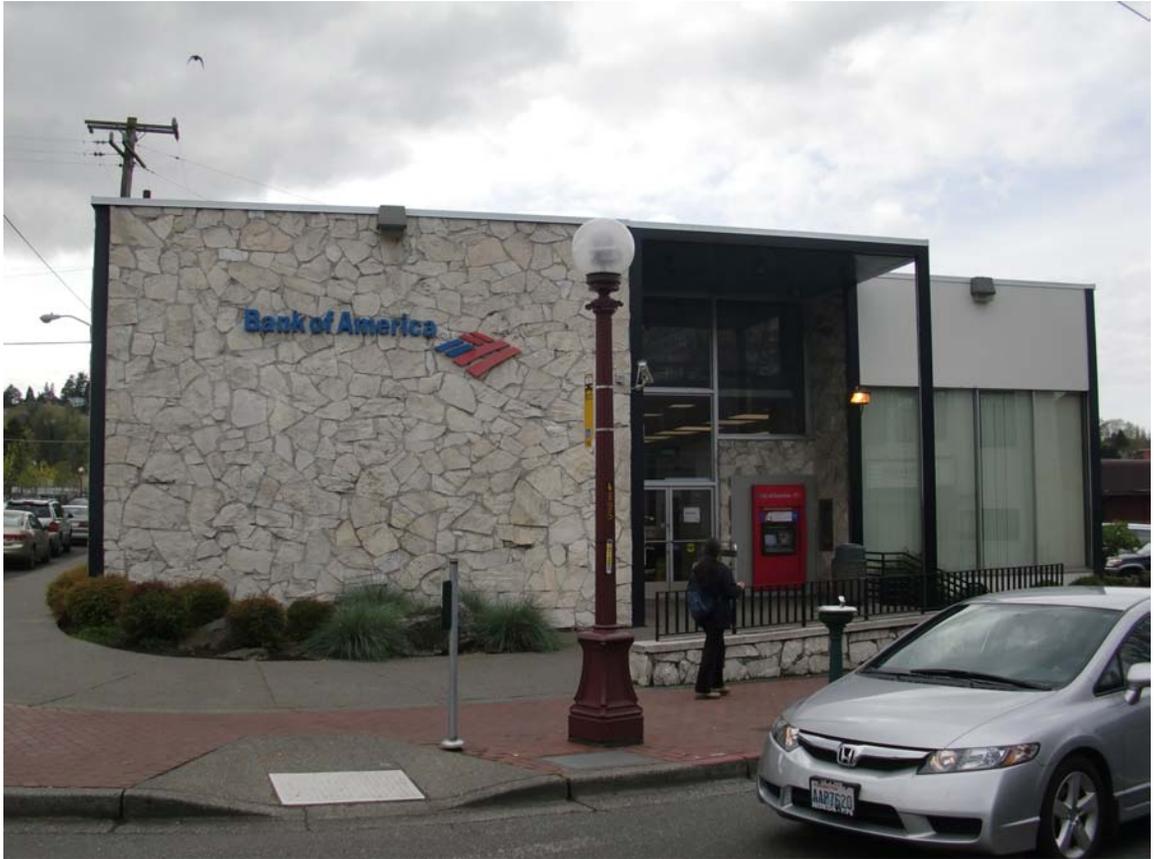
2

Effect: The Bank of America building is located at 4811-4825 Rainier Avenue South and was built in 1959, according to DAHP. The building is a non-historic, non-contributing resource to the Columbia City Historic District. From the 2004 nomination:

"This one story commercial building is of structural steel and concrete construction. The building has a rectangular plan and a flat roof. The building is clad in concrete, stone and glass. The entrance was originally located on the north side elevation facing a parking lot. The entrance has since been moved to face Rainier Avenue. This bank building was built in 1959. The architecture firm Jones, Lovegren, Helms and Jones designed the building for the Seattle First National Bank."

At the time the nomination was submitted, this building was not within the date range of significance for the district. Today, the building is intact and could be potentially a contributor to the district, though it is unlikely the nomination date range would be adjusted.

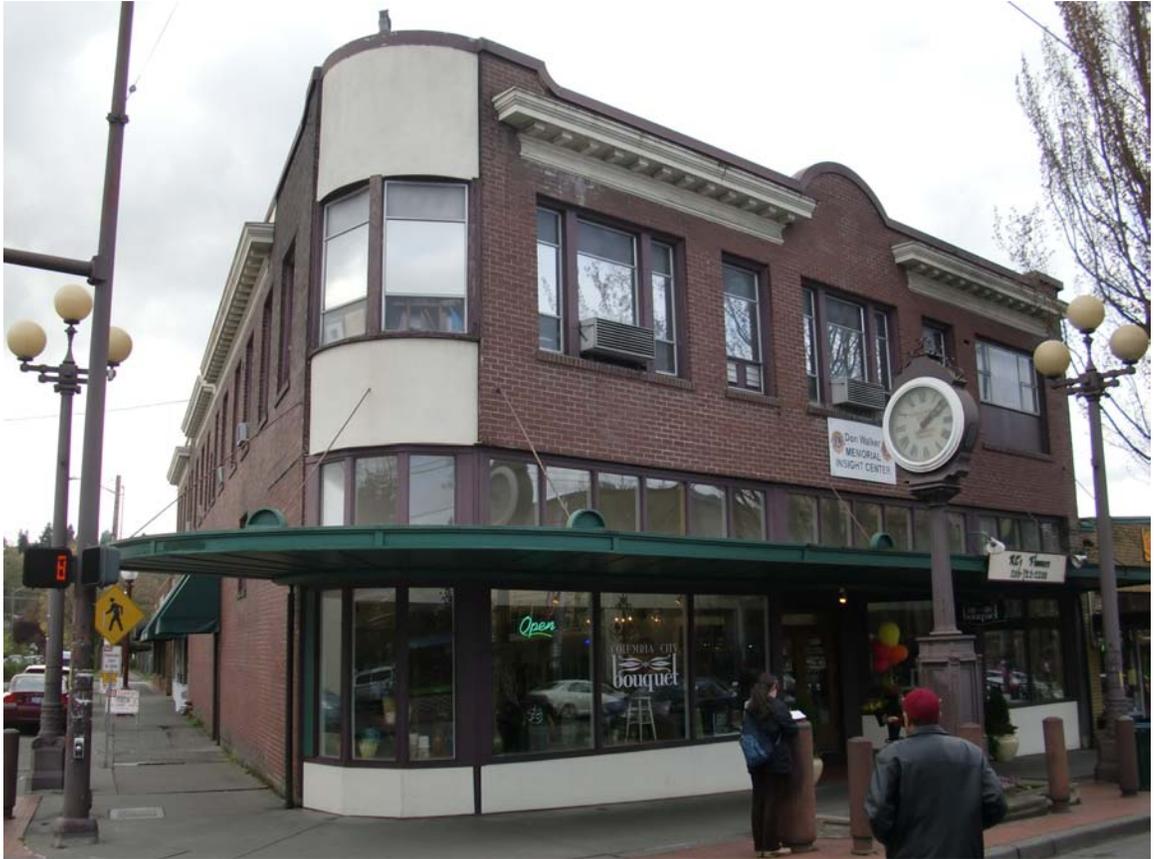
3

Effect: The Rainier Valley Investment Company Building is located at 4871-4875 Rainier Avenue South and was built in 1913, according to DAHP. The building is a historic contributing resource to the Columbia City Historic District. From the 2004 nomination:

"This two story commercial American Renaissance style building is of wood frame construction and is supported by concrete foundation. The building has a flat roof with parapet and segmented modillioned cornice. The southeast corner of the building is rounded. The fenestration consists of newer windows topped by a flat metal canopy; the window openings remain intact. The fenestration configuration on the main elevation consists of three three-part windows with single windows in-between. The south side elevation features evenly spaced single windows. The main elevation consists of a single storefront with central inset entrance. The storefront windows have been replaced, including the transom windows above the early twentieth century canopy. An entry to the upper floor and a small storefront are located on the south side elevation. Although the building has undergone extensive fenestration alterations, the form, cladding, canopy, and storefront configuration remain intact.

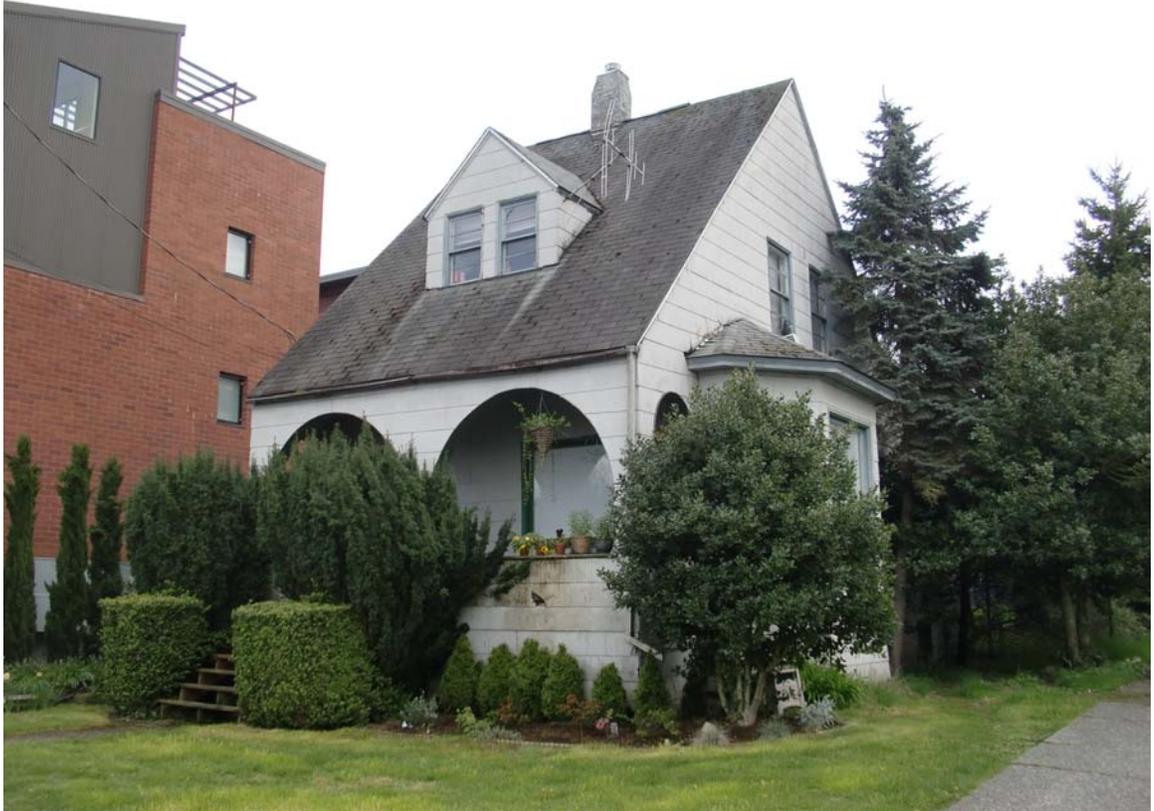
4

Effect: The vernacular house at 3823 S Edmunds Street was built in 1900, according to the King County Assessor. The house is 1.5 stories and has rectangular plan. The building is clad entirely in asbestos shingle. The eaveless, gable roof is clad in composition shingle. A gabled dormer protrudes from the center of the roof. There is a full-width, inset porch across the front with arches formed out of the asbestos shingle. Modern wood steps are used to reach the porch. Windows are 2/2 wood sash along with fixed wood sash. The house is devoid of trim. There is a polygonal bay on the west side. A painted brick chimney rises from the ridge. At the rear of the house, the roof pitch breaks to shelter a rear addition. The house appears to have been fully modernized soon after WWII. Unfortunately, the house's form is of an earlier, incompatible era; therefore, the building would not be eligible for the National Register under Criterion C due to removal of its trim and covering of its siding.

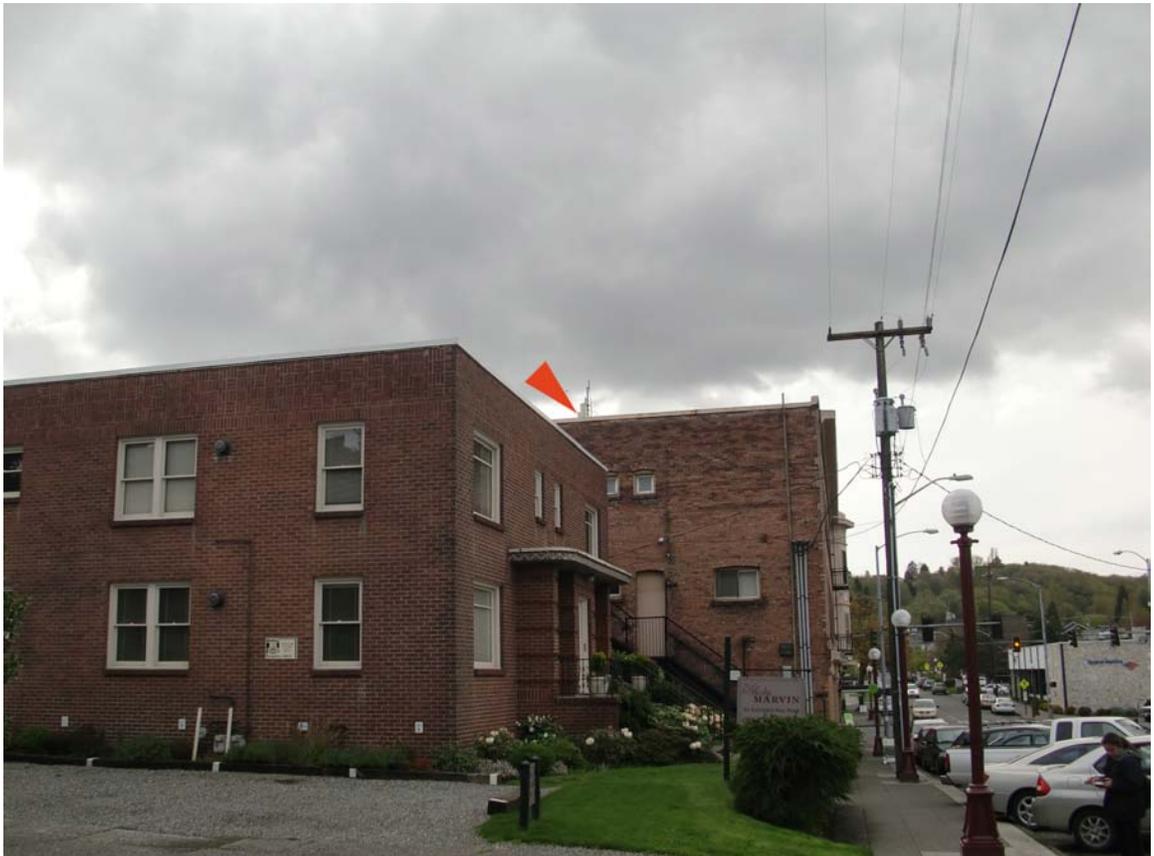
The view of the antennas is from the east side of the building approximately 110 feet away to the west. The antennas have no impact on the character-defining features or the National Register eligibility of this house; therefore, the existing and proposed antennas have no effect on this resource.

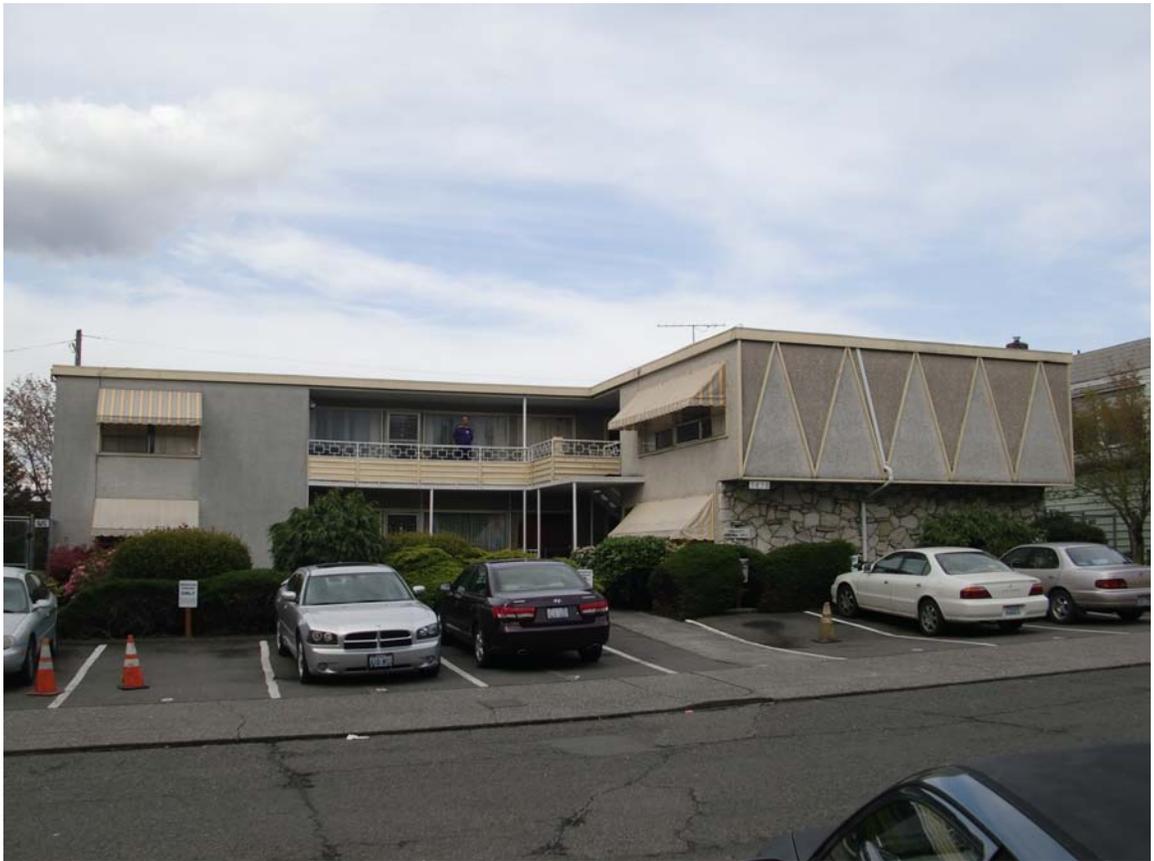
5

Effect: The modern apartment at 3818 S Edmunds Street was built in 1962, according to the King County Assessor. The two-story building has an L-shaped plan. Due to ground slope, it is three stories on the back (north) side. An exterior walkway is located at the intersection of the two volumes. The walkway is supported by metal pipe with a metal panel rail. Windows are large aluminum sash with lower vent sliders. The exterior is clad in exposed aggregate with a veneer of white stone on the southernmost wall, lower floor. On the upper half of the wall is a pattern of triangles formed with boards and alternating colors of aggregate. The roof is flat and practically eaveless with just a cornice board. The apartment appears to have had no alterations during its 50 years; therefore, the building is

eligible under Criterion C for the National Register.

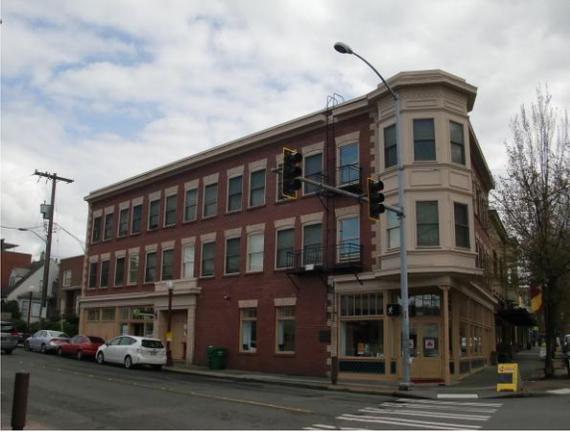
The Toby Building is located at 4850 Rainier Avenue South (alternately addressed at 3803 S Edmunds Street) and was built in 1903, according to DAHP. The building is a historic contributing resource to the Columbia City Historic District and stands at the heart of the district. From the 2004 nomination:
This three story commercial American Renaissance style building is located on a corner lot. The building is of frame construction and is supported by a concrete foundation. The building has a rectangular plan and a flat roof with decorative cornice. A two story polygonal projecting bay is located on the northwest corner of the front elevation is hold over from the Victorian era. Below the projecting bay, which is supported by a column, the corner of the building is truncated to accommodate an angled corner entry. The majority of the building is clad in brick; the projecting bay is clad in terra cotta. The fenestration consists of evenly spaced modern one-over-one single hung windows. The original window openings are intact and are topped with terra cotta segmental relieving arches with brick sills below. The building has two storefront bays on the front elevation, the main entrance is located on the corner and a smaller storefront entrance is located on the opposite end of the elevation. A single storefront and an entrance to the upper floors are located on the north side elevation. The storefronts consist of expansive glass windows with wood surrounds and transom windows above. Decorative glazed tile are located below the storefront windows. The building remains largely intact despite minimal alterations to the storefronts and the projecting polygonal bay.

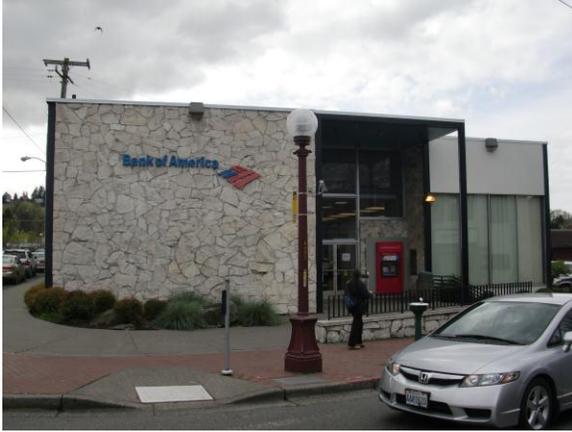
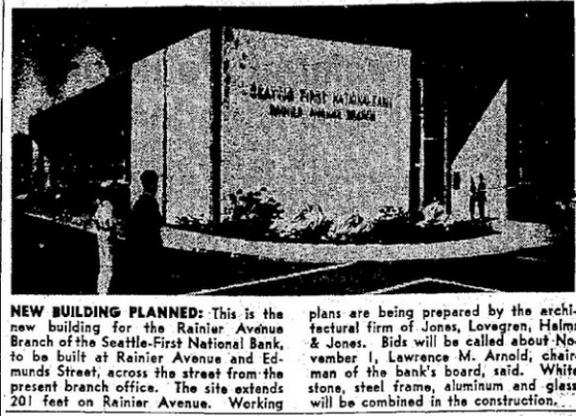
Description of Physical Appearance: The Bank of America building is located at 4811-4825 Rainier Avenue South and was built in 1959, according to DAHP. The building is a non-historic, non-contributing resource to the Columbia City Historic District. From the 2004 nomination:
This one story commercial building is of structural steel and concrete construction. The building has a rectangular plan and a flat roof. The building is clad in concrete, stone and glass. The entrance was originally located on the north side elevation facing a parking lot. The entrance has since been moved to face Rainier Avenue. This bank building was built in 1959. The architecture firm Jones, Lovegren, Helms and Jones designed the building for the Seattle First National Bank.

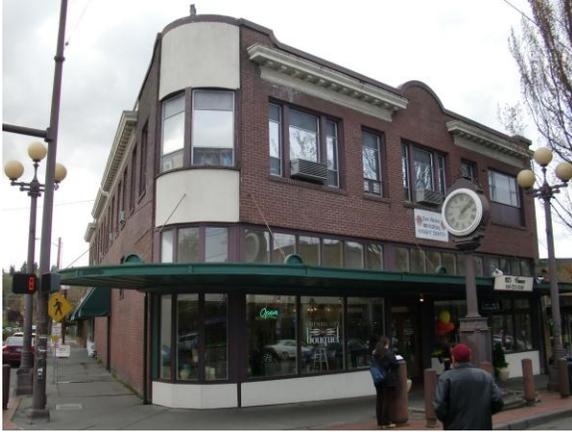
This two story commercial American Renaissance style building is of wood frame construction and is supported by concrete foundation. The building has a flat roof with parapet and segmented modillioned cornice. The southeast corner of the building is rounded. The fenestration consists of newer windows topped by a flat metal canopy; the window openings remain intact. The fenestration configuration on the main elevation consists of three three-part windows with single windows in-between. The south side elevation features evenly spaced single windows. The main elevation consists of a single storefront with central inset entrance. The storefront windows have been replaced, including the transom windows above the early twentieth century canopy. An entry to the upper floor and a small storefront are located on the south side elevation. Although the building has undergone extensive fenestration alterations, the form, cladding, canopy, and storefront configuration remain intact.
