- By: Historic Preservation Northwest 1116 11th Ave SW Albany OR 97321 541-791-9199
- For: Chris Bentley Benton County Community Development Department 360 SW Avery Ave Corvallis OR 97333 541-766-6819

INTRODUCTION

This report is a condition assessment for the Monroe Railroad Station located on Front Street in Monroe, Oregon. The report is based on a site visit made by Historic Preservation Northwest (HPNW) represented by David Pinyerd, Bernadette Niederer and Chris Bell on May 17, 2006. The site visit was on the behest of Chris Bentley of Benton County's Community Development Program. Our assigned task was to create a condition assessment report for the station building. No invasive measures were taken to analyze the building. All photos were taken by HPNW unless otherwise noted. "Preservation Briefs" are mentioned several times in this report. They are available online from the National Park Service at www.cr.nps.gov/hps/TPS/briefs/presbhom.htm

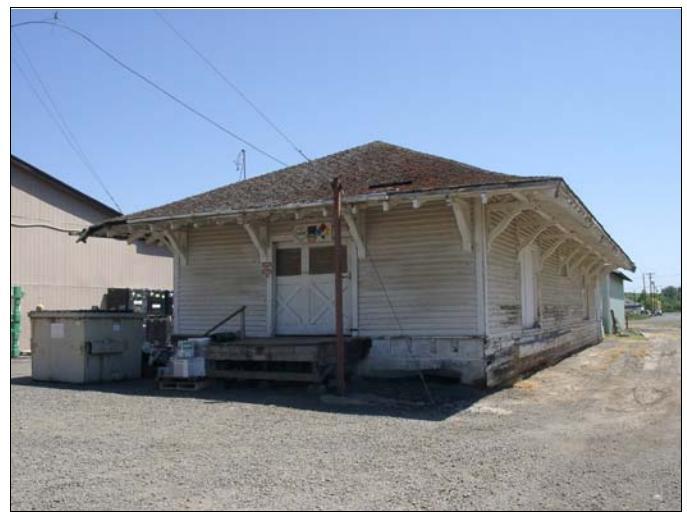
The Monroe Station in 2006. This is the north end of the station, as the south end was torn off.

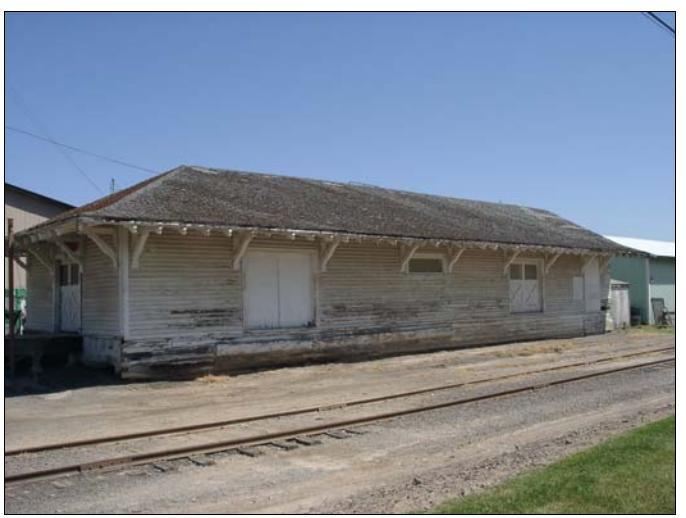
The foundation skirting is mostly replacement plywood on the east side, but on the west side, the original 7" V-notch drop siding still exists. At the south end of the building, the foundation skirting flares outward becoming battered to express the small room on the interior. This battering is visible in the historic photos of the passenger end of the building. The battering should be retained where it was implemented historically.

East elevation of the Monroe Station.

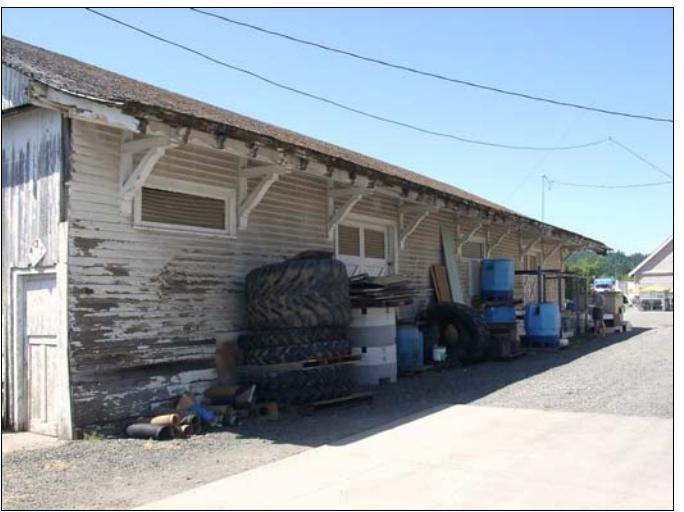
West elevation of the Monroe Station.

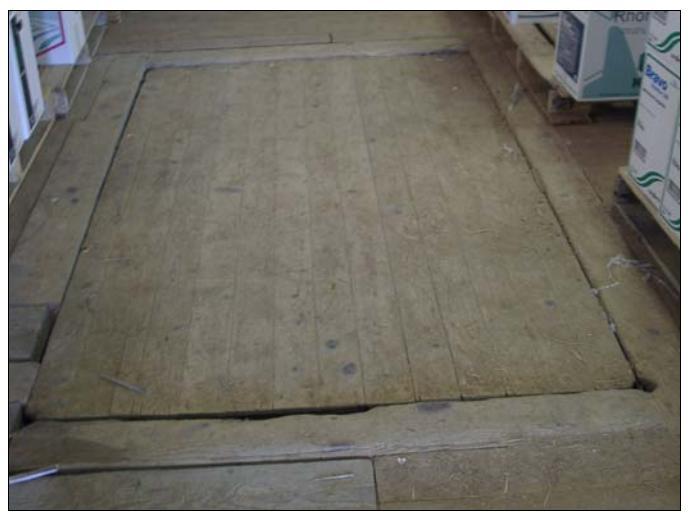
The in-floor scale in the baggage room.

no evident holes, gaps, or rotted areas. The only deviation in the regular pattern of the flooring is an inserted floor scale. The scale area is roughly 8' x 5'. It is located 5' from the east wall and is centered relative to the main space's longitudinal axis. Some of the metal parts of the floor scale are still attached under the building. The floor paneling here, which is also tongue-and-groove, runs north to south.

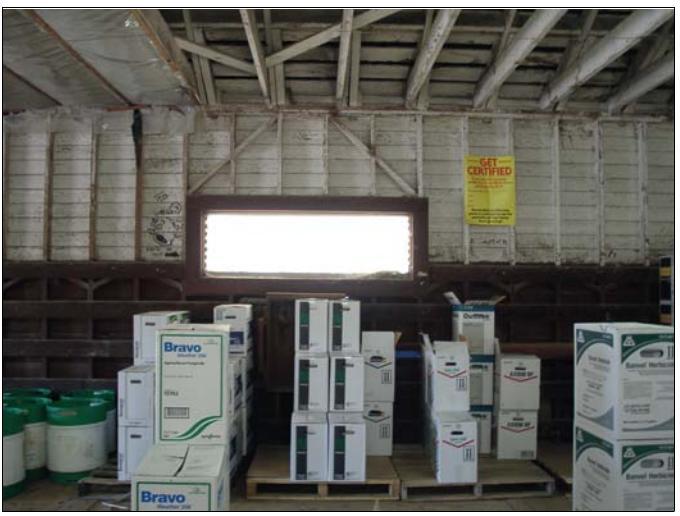
The west, north, and east elevations of the main space have exposed stud walls. The bottom 5' of the walls are painted in dark brown. Five evenly spaced boards, also painted dark brown, are attached to the bottom 5' of the stud walls as protective bumpers. The bumper boards project slightly and are attached to a separate frame system in the area of door track, thereby protecting the sliding doors when left open.

Diagonal bracing between the studs and below the top bumper board presents a zig zag pattern. Diagonal bracing can also be found above the

Framing, sheathing, bumpers, bracing and rafters all visible in the baggage room.

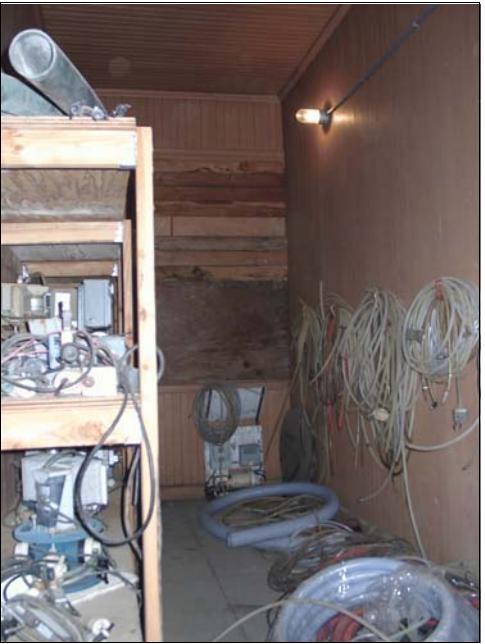
Narrow room at south end of building.

possible to determine the status of the sashes or the glazing, since it is completely covered up with a variety of wooden boards. However, its trim at least appears to be intact. The doorway leading to the stair vestibule is also trimmed out but is missing its door, quite possibly the door that now leads to the exterior. The room also boasts baseboards and crown molding.
