Condition Assessment Perrydale Station Perrydale, Oregon

By: Historic Preservation Northwest
For: The Northwest Rail Museum and the Pacific Northwest Chapter of the National
Railway Historical Society
Date: July 30, 2007

By: Historic Preservation Northwest
1116 11th Ave SW
Albany OR 97321
541-791-9199

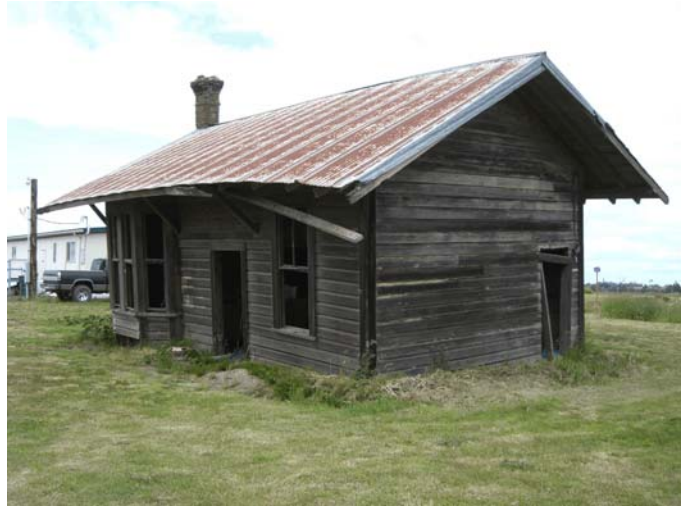
Looking northwest at the Perrydale Station.

The building's list is especially noticeable on the south wall, with a pronounced lean forward and drop to the east. Missing elements include exterior siding boards at the base of the center section of the bay, trim at the front corners of the bay, the water table along the base of the building, and a bracket that was attached to the eastern corner board. Three brackets remain. The west-most bracket is unstable because the siding board to which it is attached is coming loose. The fascia board is broken off, just to the east of the window. The south elevation is a weather side and is almost completely stripped of its paint. A very small paint trace remains to the east of the bay at the spot where a box (possibly a mail box) was mounted after 1930 but before 1960. This box no longer exists. A "Perrydale" sign dating to the postal period after the 1930s was once attached to the wall above the door. There are reports that this was donated to the Polk County Historical Museum, but unfortunately it is missing. Some porcelain insulators for electrical wiring can also be seen attached to the frieze board.

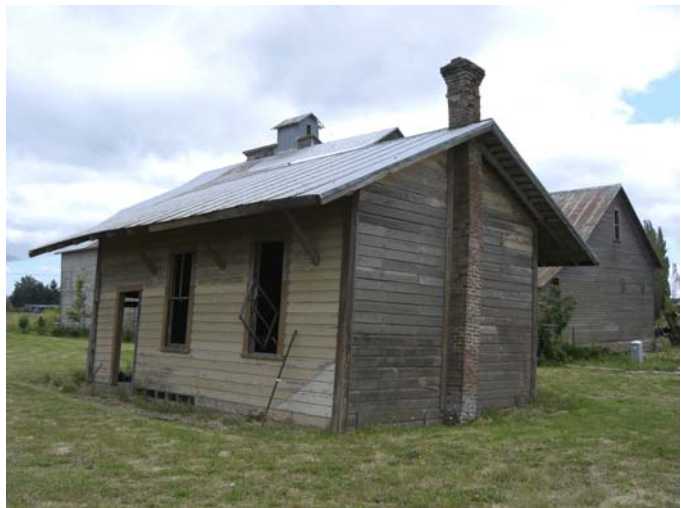
Looking southeast at the Perrydale Station.

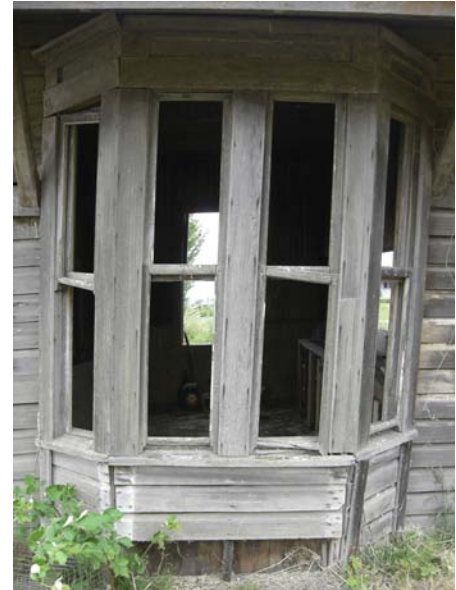
The polygonal bay is the most character-defining feature of the station.

The polygonal bay on the west end of the south elevation includes four narrow windows, two on its front wall and one on each of the slanted side walls. These windows consist of single pane double hung sashes each measuring 1'6" by 3'6".

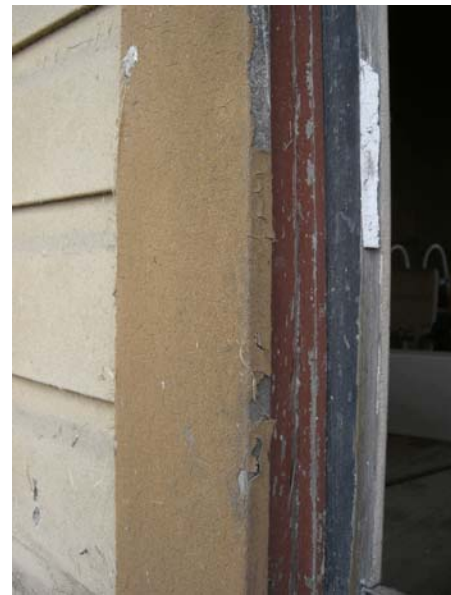
The best paint colors for sampling appear on the north side.

As for color selection, a paint analysis should be performed on the station. Most likely the analysis will reveal that it was originally painted Southern Pacific yellow (a butterscotch yellow) for the body color with dark mustard trim and rich brown accents at the window sashes. The Springfield, Oregon, station was restored and painted its original colors. The City of Springfield could be contacted for color guidance after the paint analysis, along with those familiar with the standard Southern Pacific station colors.

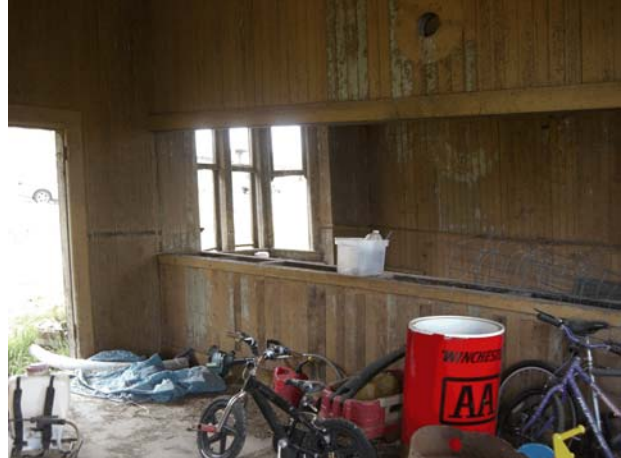
Looking southwest from the passenger area towards the counter.

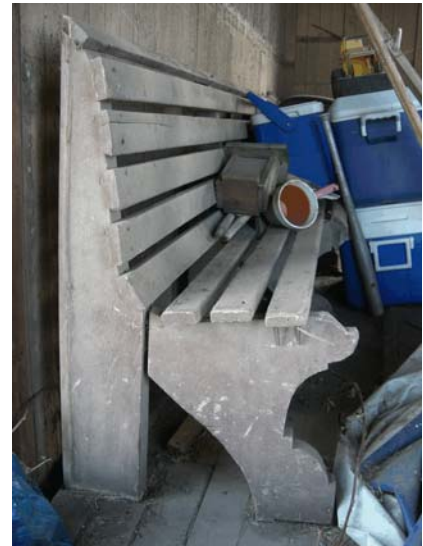
The built-in bench on the east wall.

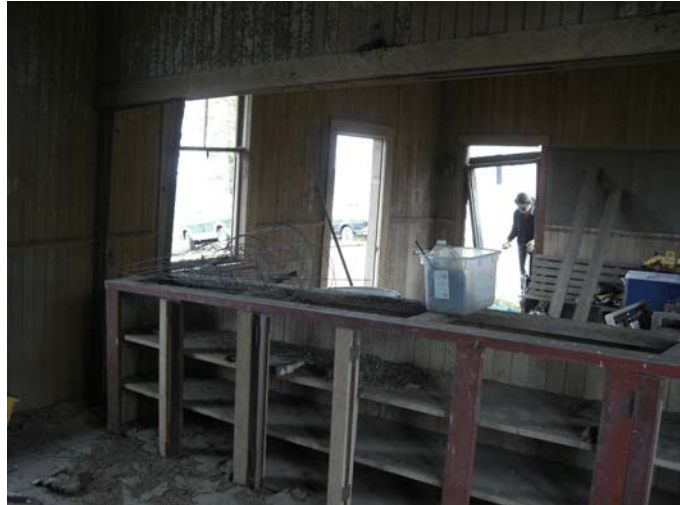
All of the station's interior walls as well as the passenger side of the counter and the soffit above the counter are covered with 3-1/2" tongue and groove bead board. A molded chair rail set at 3'-10" runs around the perimeter of the room. The railing is fairly intact, with a few gaps along the south wall. The railing of the east wall was removed at the 3'-10" level but still appears higher on the wall. This double railing contains an area of darker paint that was perhaps used as a message board. The station's ceiling is covered in 3-1/2" tongue and groove.

Looking northeast from the station master's area to the passenger area.
